Tile-SiPM Systems for AHCAL

Michael Danilov (ITEP, Moscow)
CALICE Collaboration

ECFA ILC Workshop Vienna 2005

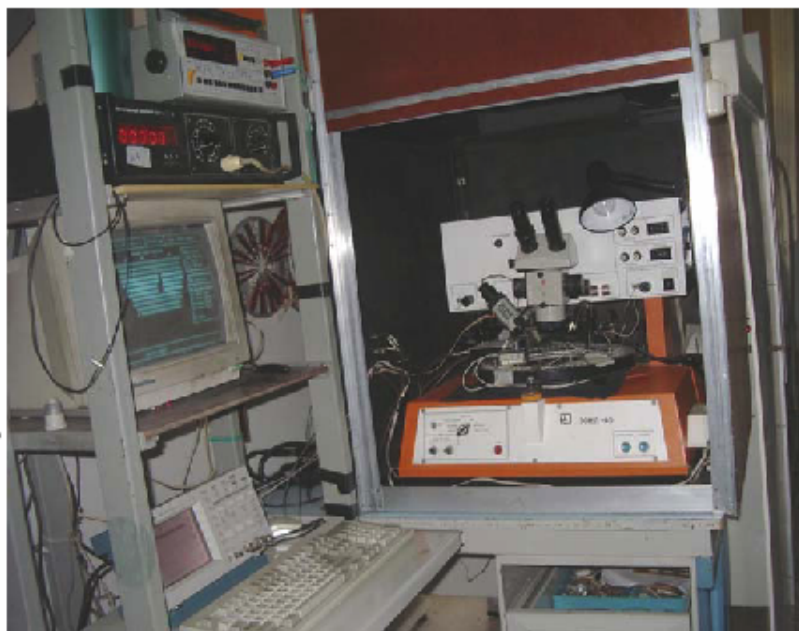
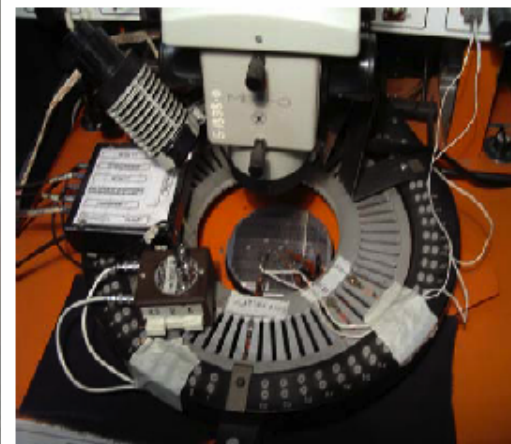
PULSAR semiautomatic probe station for the initial SiPM selection on the uncut wafer

- Proper Geiger signal to the LED pulse
- For operational voltage when SiPM response has amplitude A SiPM current should be less than certain value

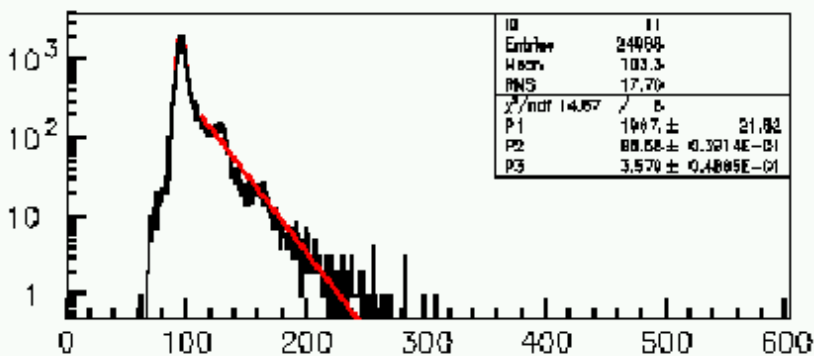
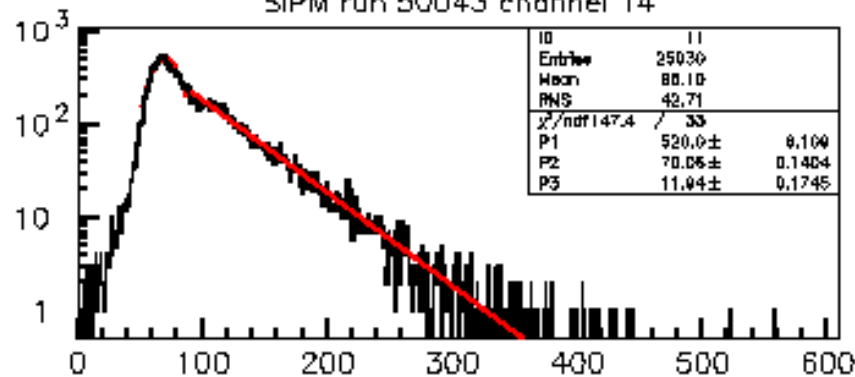
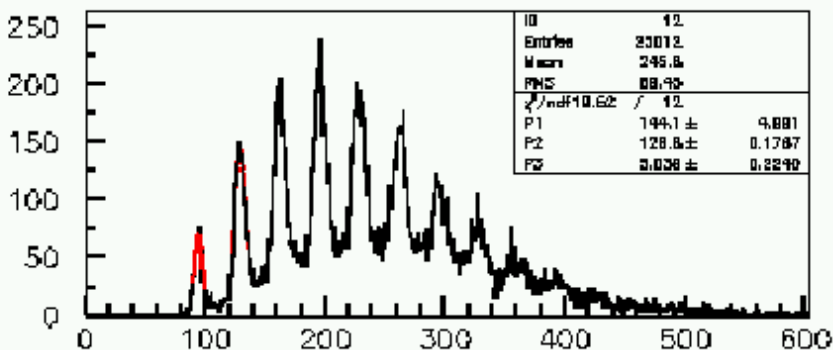
Spectra below show the difference between a good and a typical rejected SiPM

The left one has noise frequency – 1.5MHz

The right one has noise frequency 2.8 MHz, Noise at 0.5MIP is above 2kHz

Note the difference in pe peak separation and in the slopes of the tail

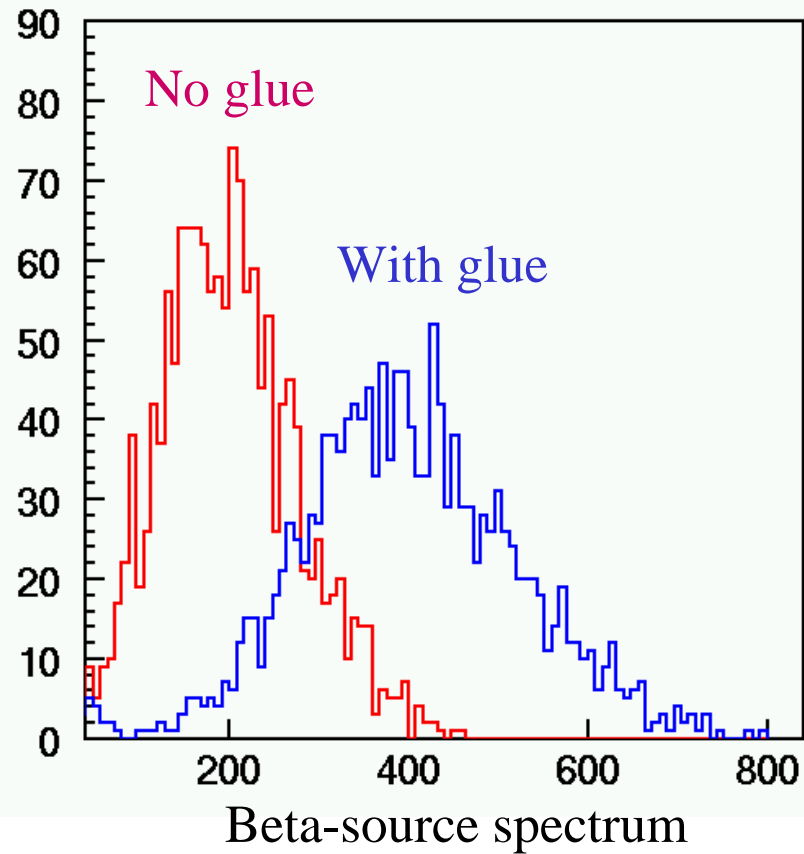
Gel Influence

LY can be increased by a factor of about 1.9 by gluing fiber to SiPM with “SUREL SL-1” siloxane gel
